IN THE UNITED STATES DISTRICT COURT
FOR THE NORTHERN DISTRICT OF TEXAS
ABILENE DIVISION

CIVIL ACTION NO. 1:18-CV-00062

**APPENDIX TO PLAINTIFF'S BRIEF IN SUPPORT OF ITS RESPONSE TO
DEFENDANT'S RENEWED MOTION FOR PARTIAL SUMMARY JUDGMENT**

Exhibit	Title	App. Range
A	Affidavit of Scott Taliaferro, Jr.	Pp 3-43
B	Affidavit of Mark Reed	Pp 4-51
C	Excerpts of the Deposition of Leslie Ederer	Pp 52-103
D	Pratt & Whitney Canada Engine/Component Investigation Report	Pp 104-131

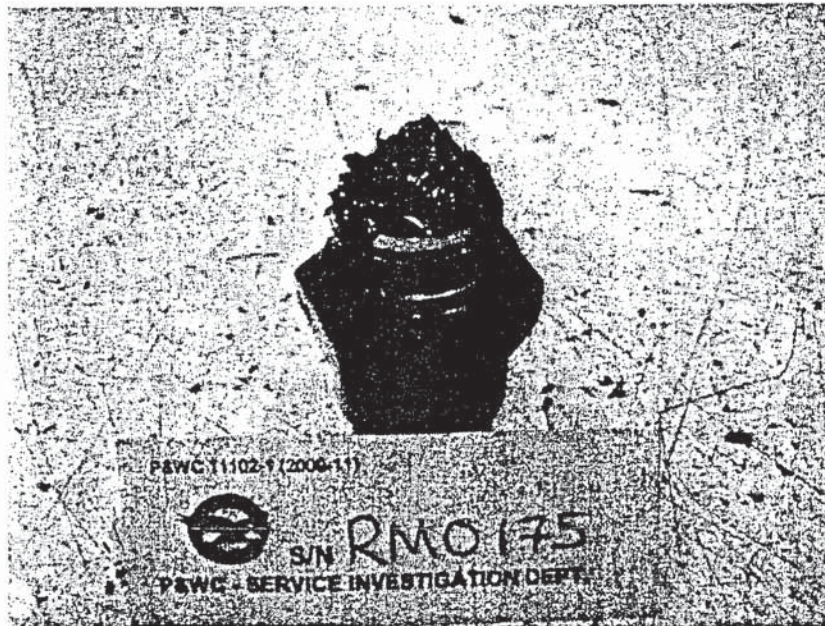
Photo No. 1

2.2 The AGB magnetic chip detector (MCD) poles were bridged with metallic debris (Photo No. 1).

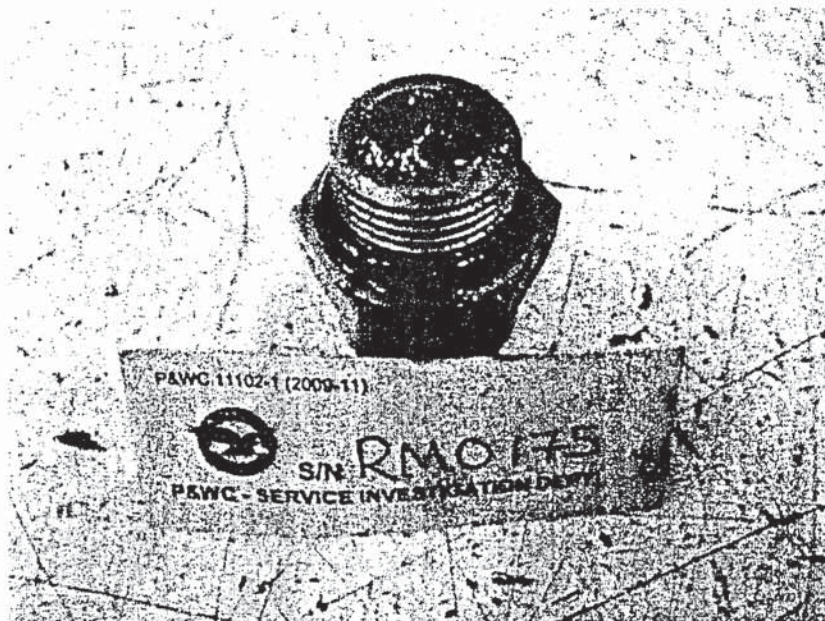
Photo No. 2

2.3 The RGB MCD showed metallic debris and bronze colored metallic particles (Photo No. 2).

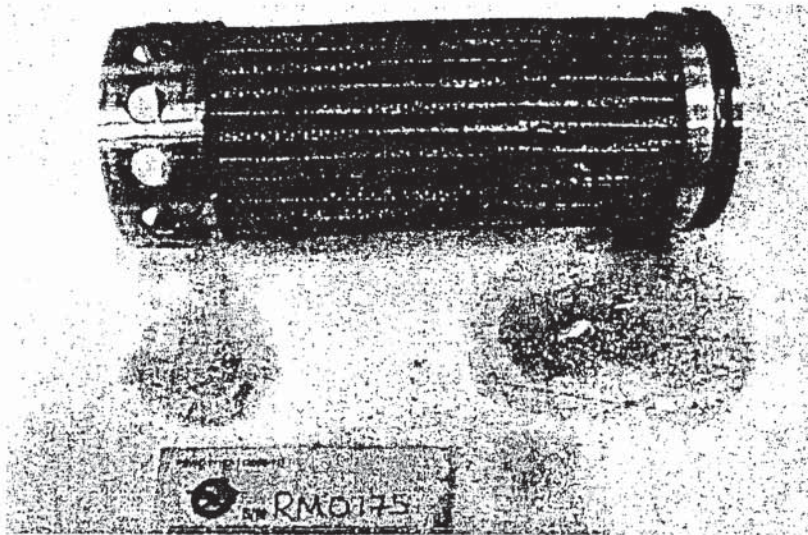
Photo No. 3

- 2.4 The main oil filter showed metal debris contamination (Photo No. 3).

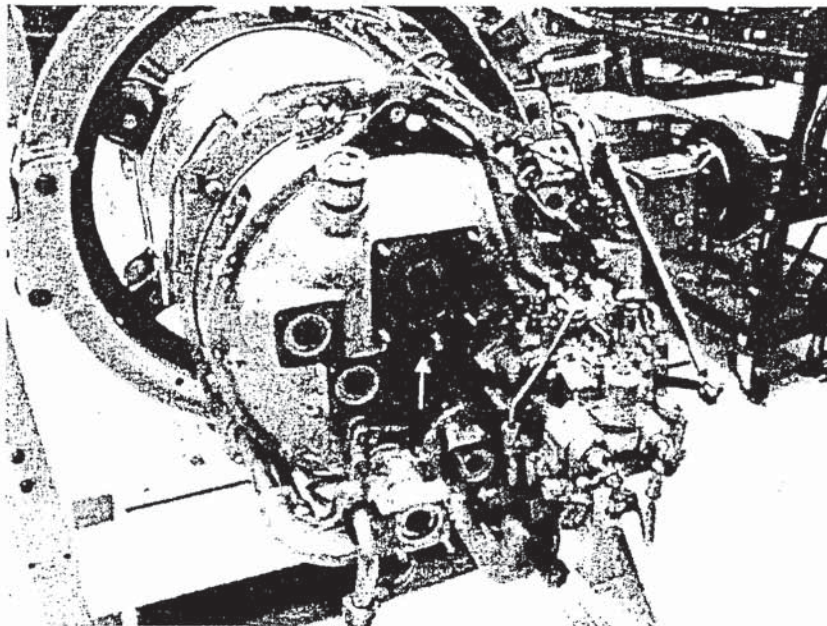
Photo No. 4

- 2.5 The AGB was dirty but showed no major oil leakage (Photo No. 4). The threaded oil nozzle (P/N 3116530-01) was removed (arrow, Photo No. 4) and found fractured (Photo No. 5, shown with the fractured pieces recovered later during disassembly). The AGB drive gearshaft (P/N 3116496-01) bearing journal was observed out of position through the AGB housing (arrow, Photo No. 6). The AGB assembly was removed without having to unlock the spring lock insert.

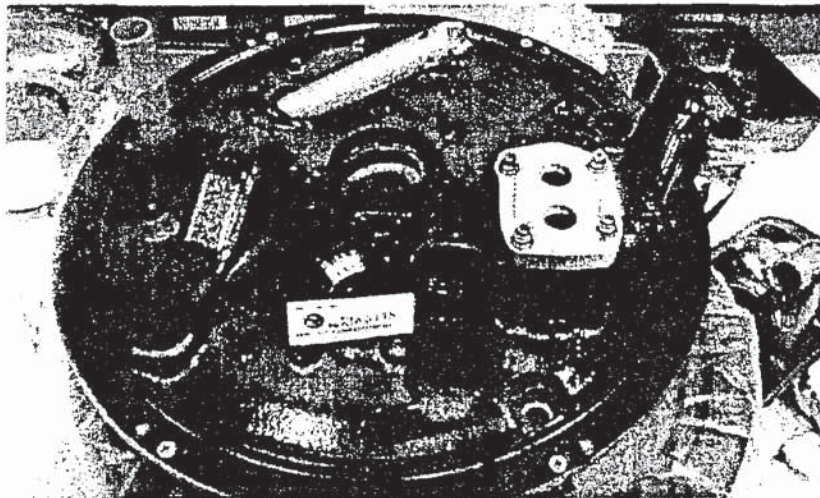
Photo No. 11

- 2.8 The AGB assembly housing as removed showed no distress (Photo No. 11). The main oil pump was removed and could be freely rotated. Disassembly of the main oil pump found no distress. The oil filler tube check ball was found in good condition.

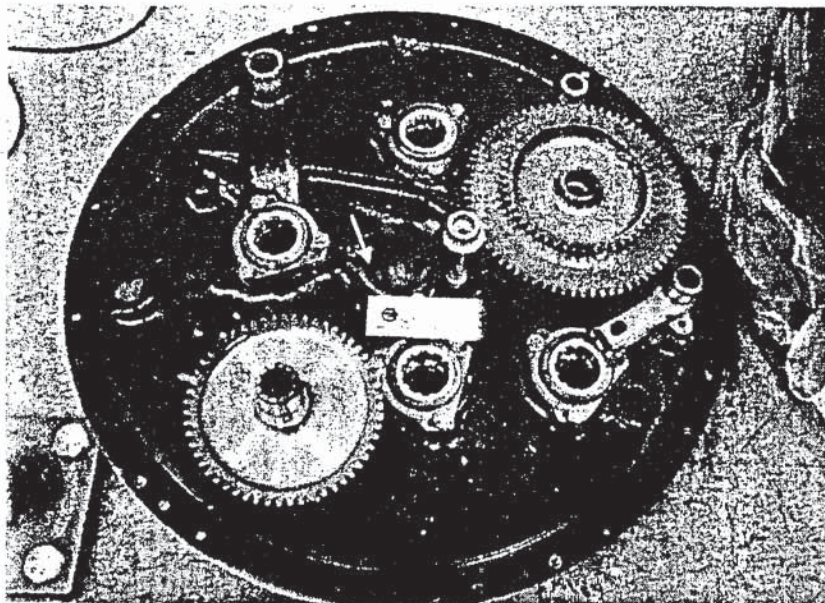
Photo No. 12

- 2.9 The AGB diaphragm was split from the AGB housing revealing metal debris contamination and the distorted remnants of the flanged outer ring of its accessory bearing (P/N 3037278 from records, as P/N and S/N not legible) at diaphragm boss No. 3 (arrow, Photo Nos. 12 and 13). The triple key washer was in place with the tabs properly secured. The bearing seat was also damaged and cracked in line with the retaining bolt holes (arrows), resulting in the displacement of the helicoil inserts during the bearing removal (Photo No. 14). The remaining accessories roller bearings showed no distress. The external scavenge pump gearshaft drive and the oil pump drive gearshaft showed no primary distress only secondary damages from overrunning metallic debris (Photo No. 12). The flanged oil transfer tube was found unobstructed (red arrow, Photo No. 12).

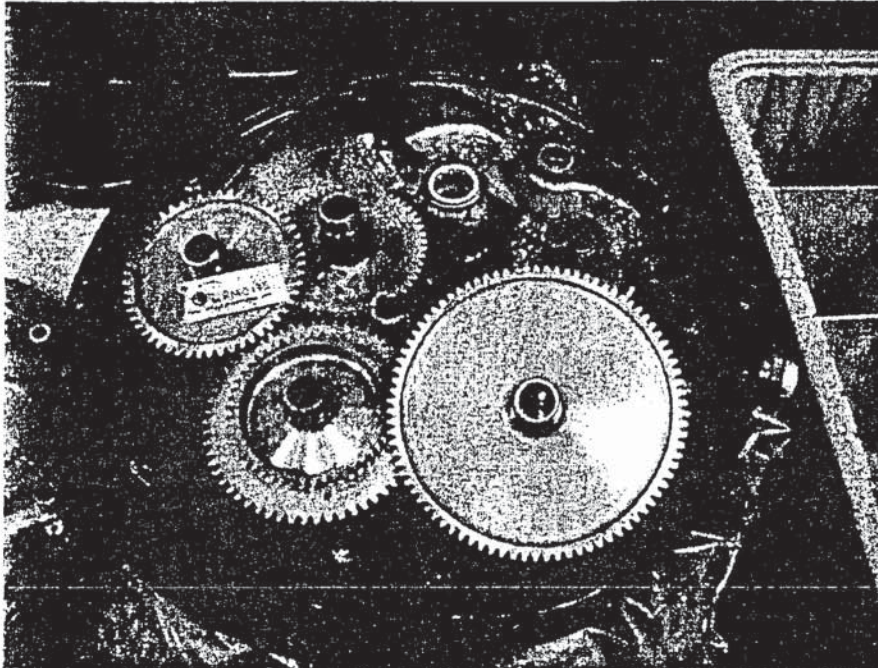
Photo No. 15

- 2.10 The AGB housing showed metal debris contamination (Photo No. 15). The gearshafts except the AGB drive gearshaft were removed. The starter generator gearshaft drive and an accessory gearshaft drive showed secondary mechanical damages (Photo No. 16). The centrifugal breather impeller showed material loss from the outer circumference from contact with the AGB drive gearshaft teeth (Photo No. 17). The fuel control drive gearshaft and second accessory gearshaft drive showed no significant damages.

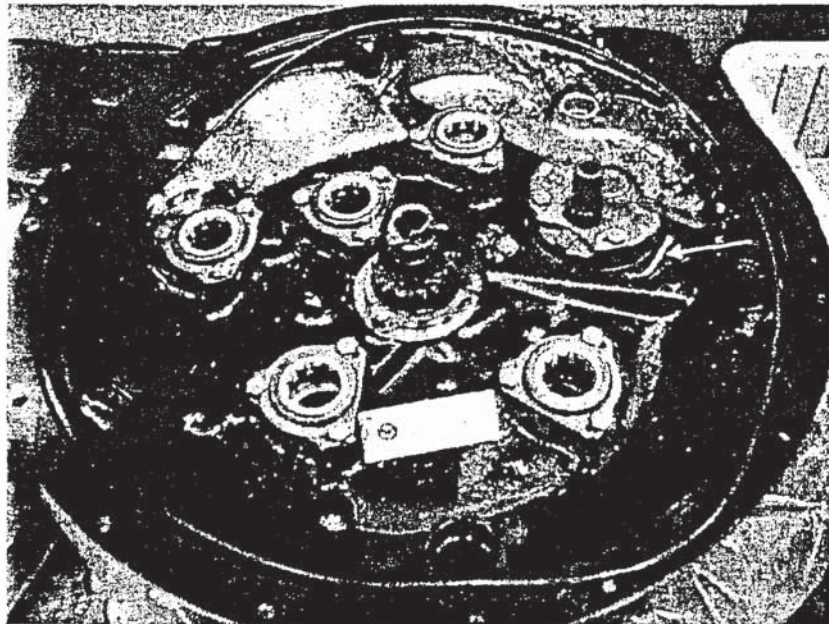
Photo No. 18

1 gearshaft remnants (Photo
2 No. 18 and 19) showed
3 offset gear teeth wear
4 (shaft moved towards the
5 AGB housing side) and
6 orbiting resulting in
7 significant material loss
8 (red arrow Photo No. 20)."
9 Back again to photo 20.

- 2.11 With the gearshaft removed, the AGB housing revealed the battered and bent front oil nozzle section from the fractured threaded oil nozzle (arrow, Photo No. 18). The fractured AGB drive gearshaft remnants (Photo No. 18 and 19) showed offset gear teeth wear (shaft moved towards the AGB housing side) and orbiting resulting in significant material loss (red arrow Photo No. 20). The AGB drive gear teeth (Photo No. 20) showed no indication of prior tooth contact pattern wear on either side of the intact tooth remnants (Photo No. 21). Both bearing journals of the AGB drive gearshaft also showed orbiting and offset wear resulting in material loss of the journals (Photo No. 19). The journals, based on the wear, appear to have moved toward the housing side relative the rollers fixed locations (dashed arrows, Photo No. 20).

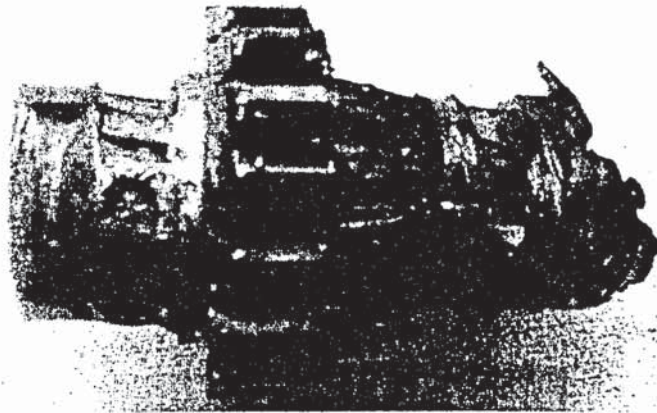
Photo No. 19

1 also showed orbiting and
2 offset wear resulting in
3 material loss of the
4 journals, photos number 19.
5 The journals based on the
6 wear appear to have moved
7 towards the housing side
8 relative the rollers fixed
9 location (dashed arrows,
10 Photo No. 20)."
11 Going to 19 and 20, it points out
12 where the wear was observed.
13 Q. And that was paragraph 2.11?
14 A. Correct.
15 Q. All right. Is there any other portion
16 of the Investigation section which supports
17 that conclusion?
18 A. There is, in 2.11 --
19 Q. So is that the same paragraph we were
20 just discussing?
21 A. Yes, 2.11.
22 Q. Okay. Go ahead, I didn't mean to stop
23 you.
24 A. The second sentence:
25 "The fractured AGB drive

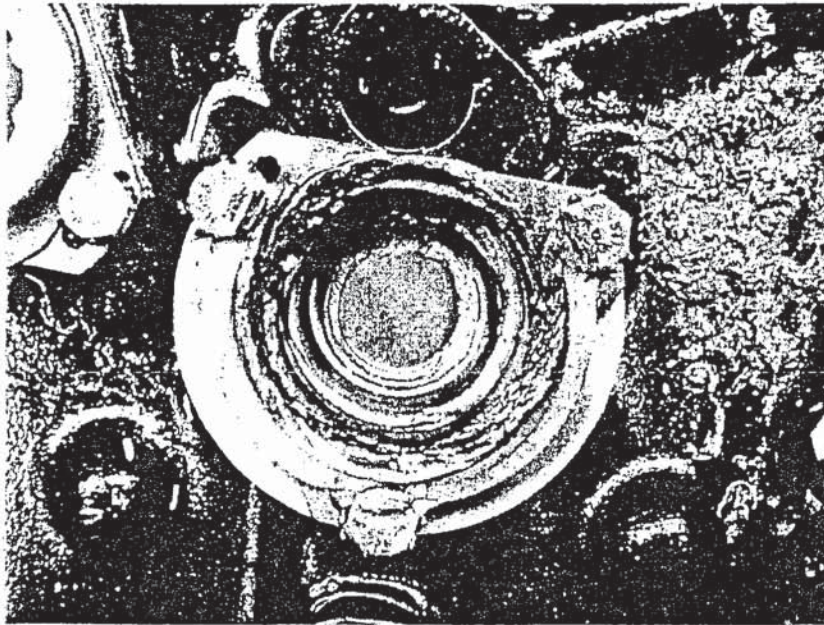
Photo No. 22

- 2.12 Removal of the AGB drive gearshaft revealed the distorted remnants of the flanged outer ring of its accessory bearing (P/N 3037278 from records, as P/N and S/N not legible) at housing boss No. 3 (Photo No. 21). The flat spacer, and triple key washer was in place with the tabs properly secured. The bearing support sleeve seat showed rubbing damage (Photo Nos. 22 and 23). The remaining accessories bearings showed no distress (Photo No. 23).

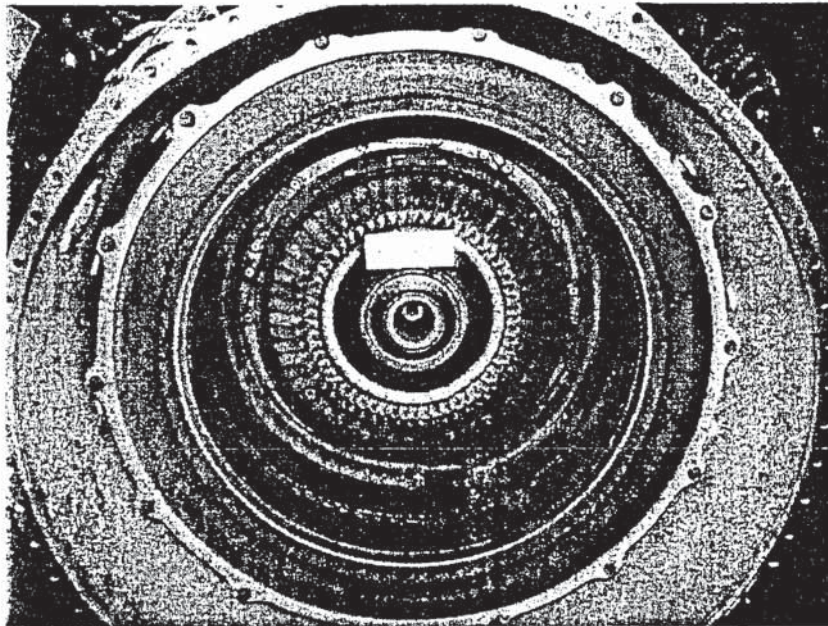
Photo No. 24

- 2.13 The engine was split at the "C" flange with no distress observed on the compressor turbine (CT) and PT blades (Photo No. 24). No distress was observed with the inter turbine temperature system.

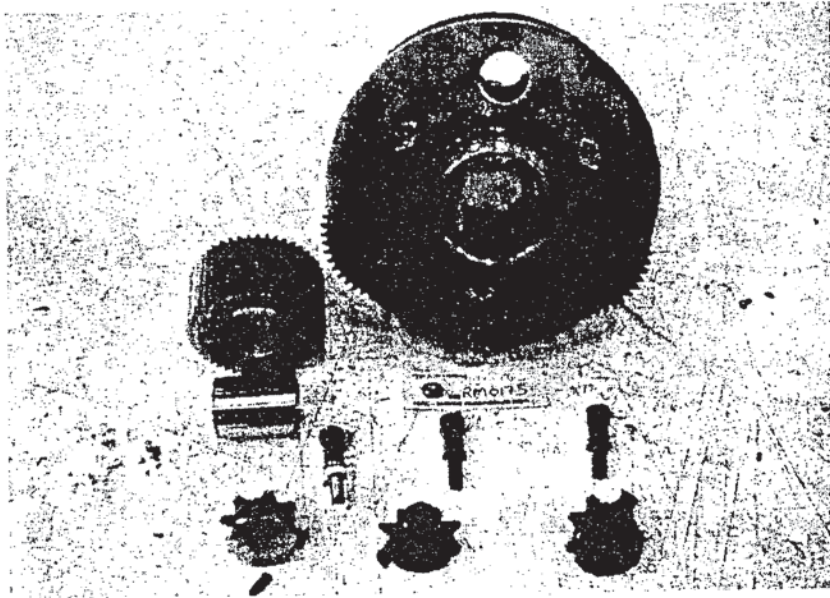
Photo No. 35

- 2.15 The RGB was removed and disassembled revealing the first stage carrier flange at the location of the planet gears "X" and "Z" to be significantly heat tinted (Photo No. 33). All three first stage planet gears could be rotated. The planet gear carrier bearing journal showed no distress. The planet gear carrier was disassembled, but due to distress of the "X" and "Z" planet gears' bushings they could not be removed (Photo Nos. 34 and 35). Removal of the oil strainers, showed the "X" and "Z" planet gears were discolored with carbonised oil, showed no evidence of any oil wetness (Photo No. 35). The second stage carrier assembly showed no distress.

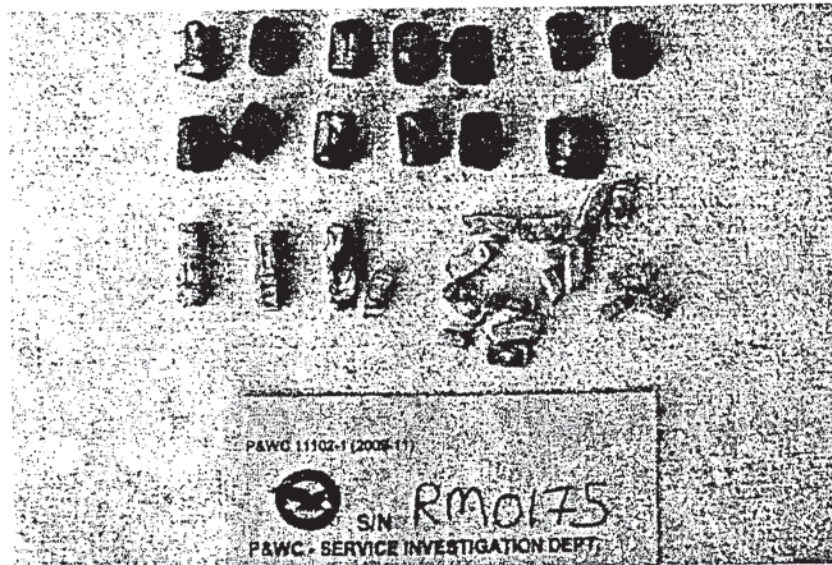
Photo No. 36

- 2.16 From the debris recovered in the AGB front housing 13 rollers, pieces of bearing cage crossbars and side rails were found and (Photo No. 36). It could not be determined from which of the two accessories bearings (10 rollers each) the rollers and cage pieces had originated from. Due to the damages on all the recovered rollers and cage cross bars it was not possible to characterise their condition prior to the damages (Photo Nos. 37 and 38). The cage side bars that could be characterised showed significant roller end face contact wear resulting in wear ridges corresponding to the outside diameter of the rollers (arrows, Photo No. 39). Although many of the side rails fracture surfaces showed significant rubbing obliterating the original fracture surface (Photo No. 40) some still showed evidence of river lines (arrows) and a flat region indicative of fatigue (Photo No. 41).

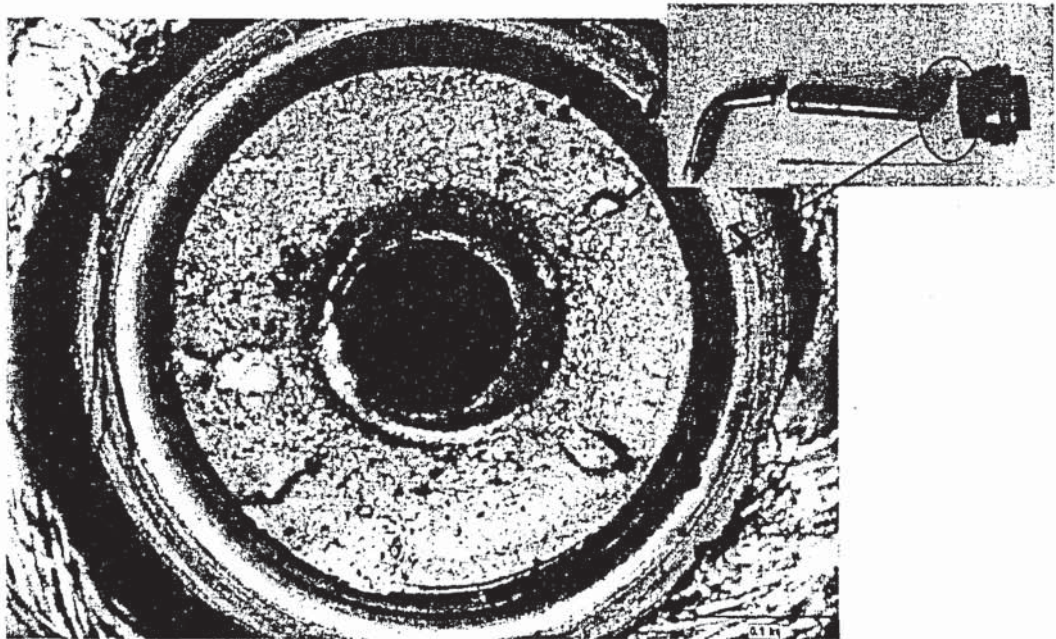
Photo No. 42

- 2.17 The fracture surfaces of the oil jet nozzle assembly were examined and were both found to be indicative of overload fractures (Photo Nos. 42 and 43).

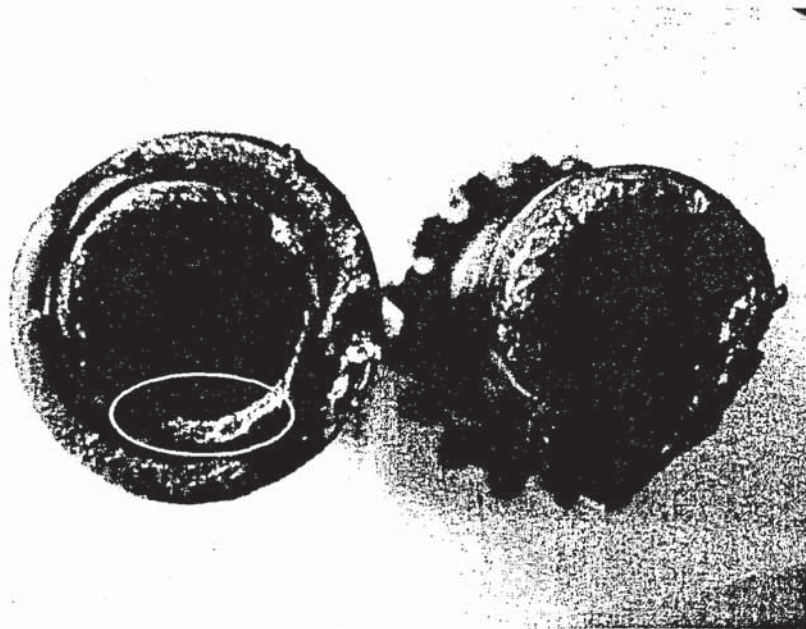
Photo No. 44

- 2.18 The fracture surfaces of the AGB gear shaft drive were significantly battered (Photo No. 44) resulting in only a small fracture region on the splined end (circled, Photo No. 44) that could be examined (circled, Photo No. 44). The fracture surface which slanted towards 45° was indicative of shear overload (Photo No. 45).

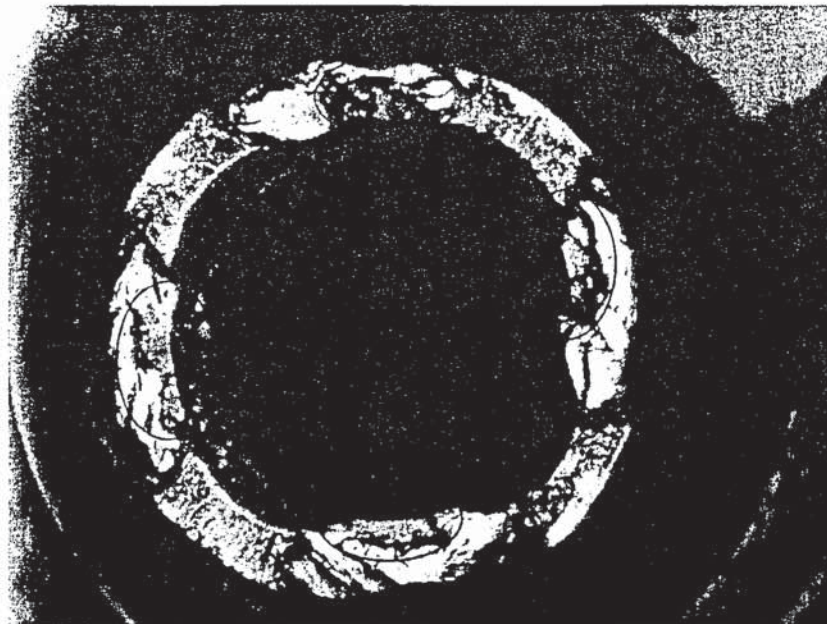
Photo No. 46

- 2.19 The spring lock insert fracture surfaces showed significant rubbing damages, however in small undamaged regions the original fracture surface could still be observed (Photo No. 46). The fracture surface morphology of these regions showed flat surfaces with, river lines and beach marks indicative of fatigue crack propagation (Photo No. 47). The fracture surfaces on the spring lock legs showed similar features (Photo No. 48).
